Building Abstract

Main Building

Building 2

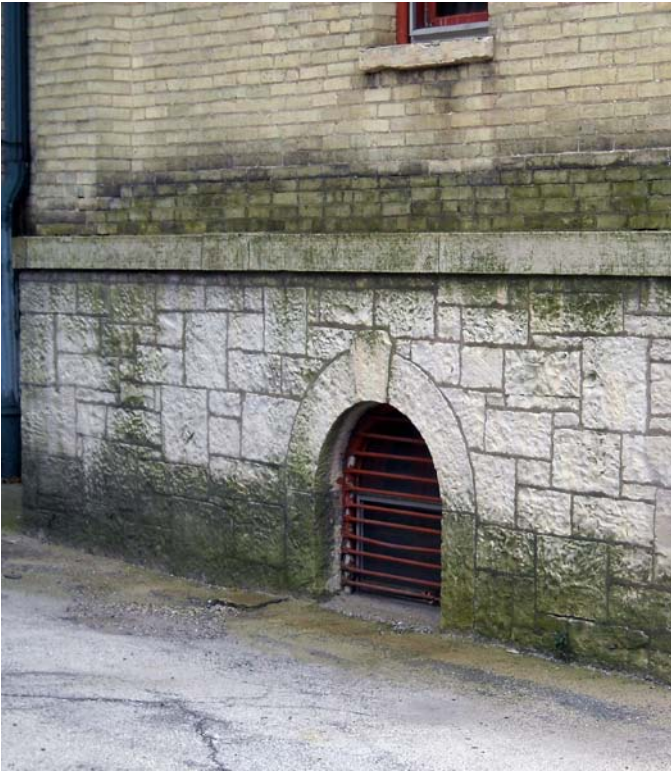
1 Dirt and pollutants on stone foundation wall.

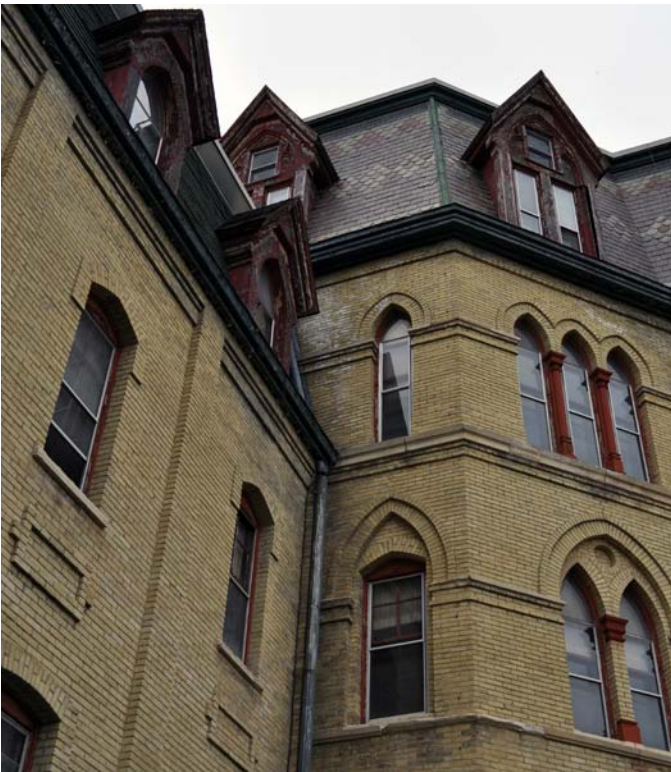
3 Efflorescence and stains on brick wall. Spalled stone window sill. Peeling paint at windows.

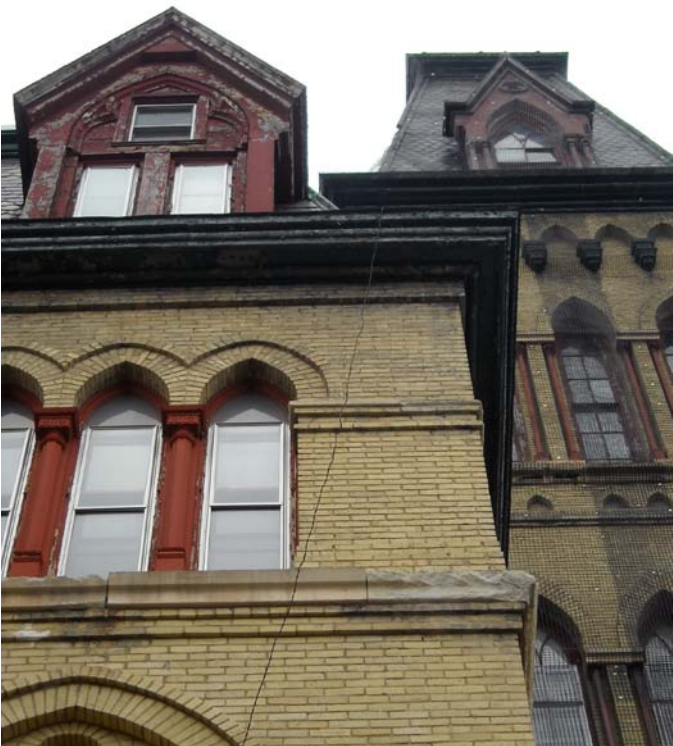
7 Spalled stone trim and lintel. Loose electrical cable. Peeling wood dormer.

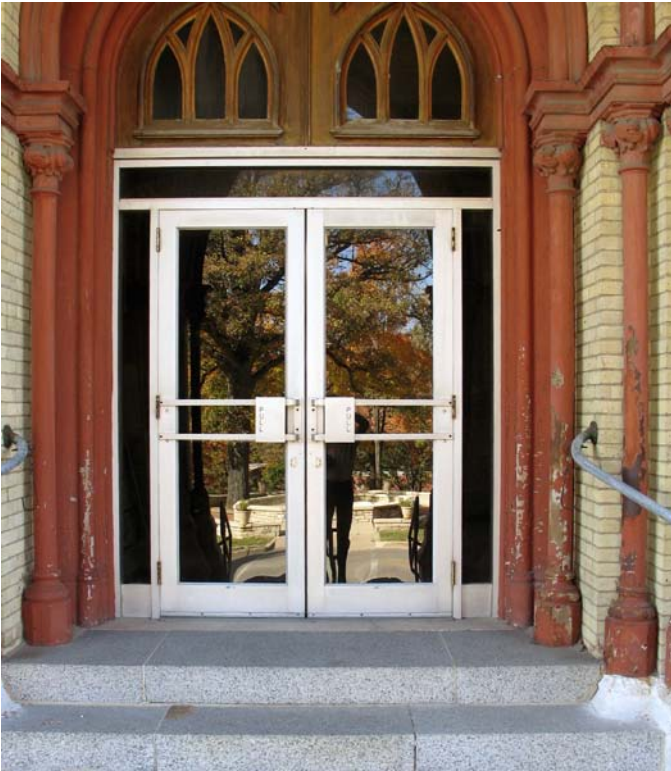
9 *Inappropriate aluminum storefront entry door. Peeling paint at steel columns.*

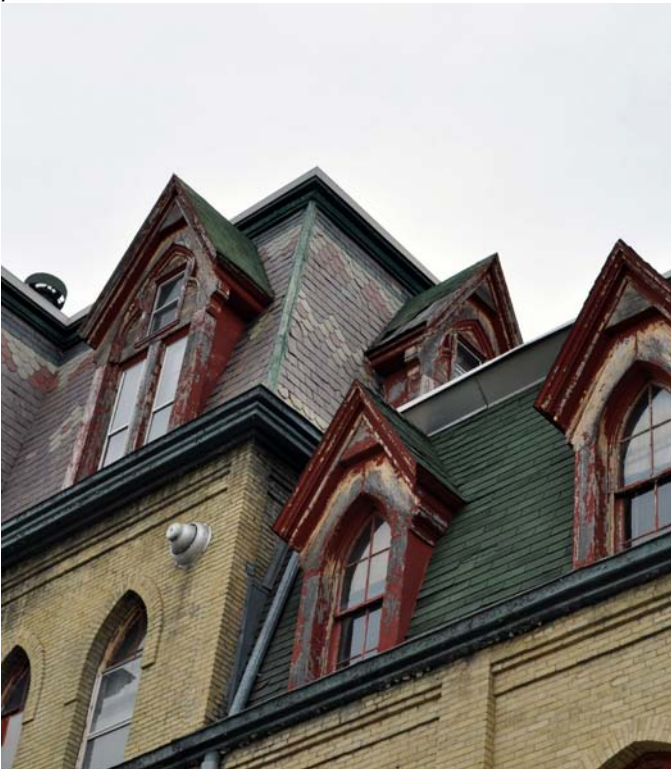
11 *Damaged asphalt shingles. Inappropriate slate replacement. Paint peeling at dormers. Deteriorated tin roof. Inappropriate roof coping material.*

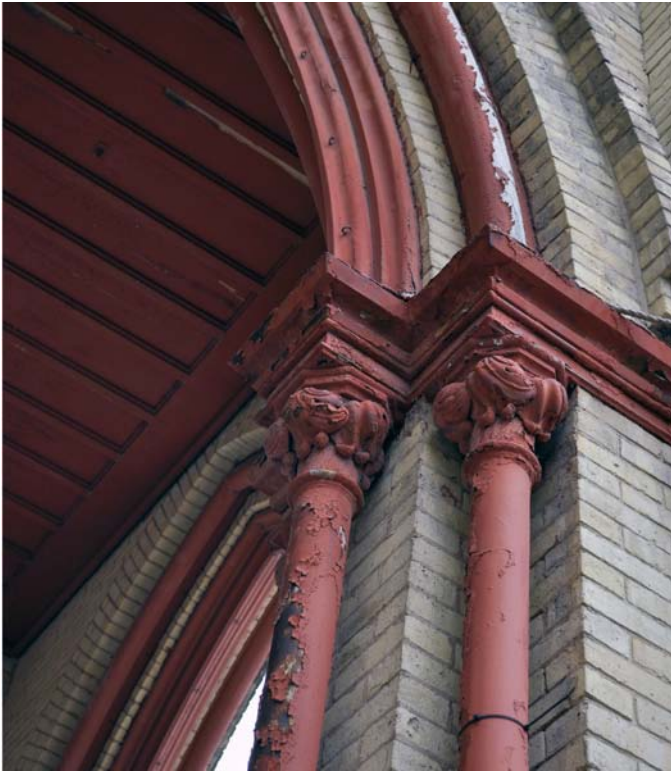
17 Peeling paint on steel columns and wood trim. Unused hardware, plastic ties and rope.

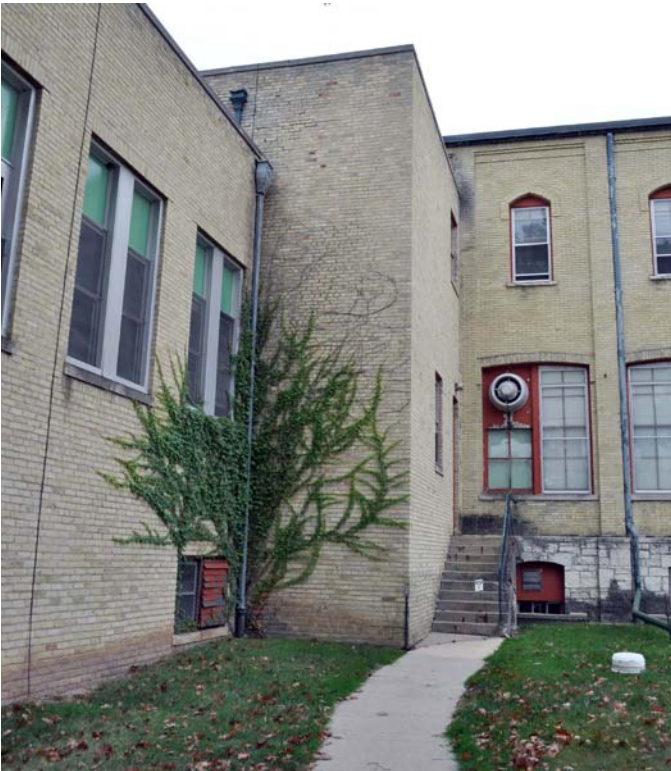
19 Vegetation and stains on masonry walls. Efflorescence on brick wall. Inappropriate window infill.

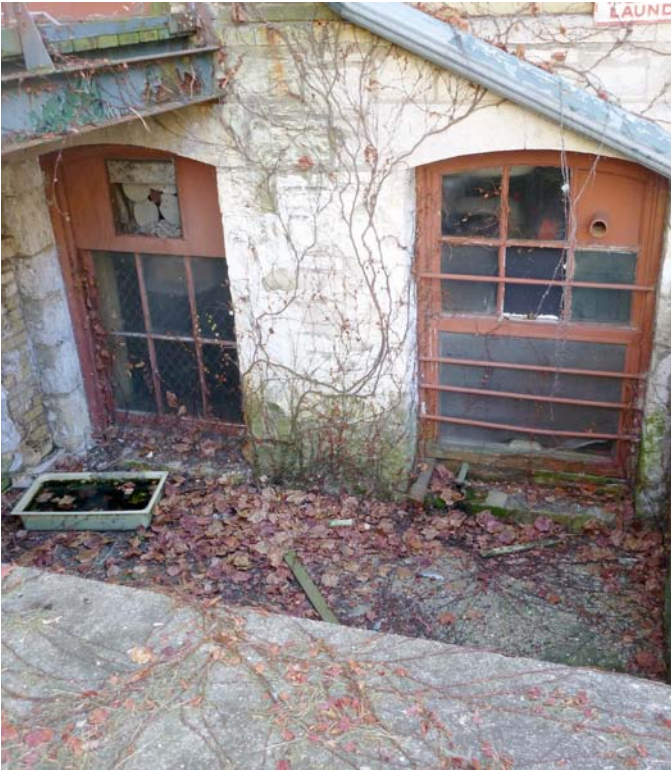
25 Deteriorating windows. Vegetation and debris in area well. Peeling paint on windows, stairs and downspout. Deteriorating brick.

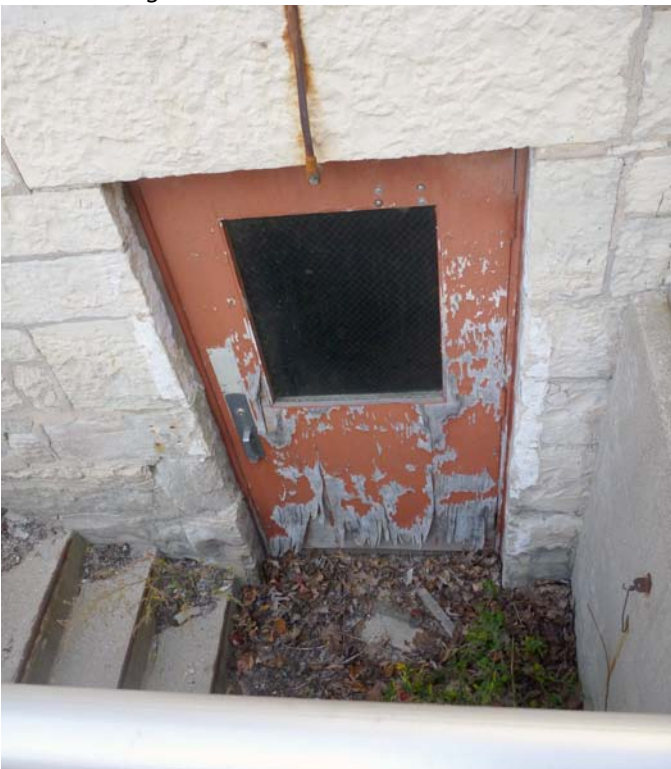
27 Deteriorating door. Vegetation and debris in stair well. Rust stain on stone. Paint stain on stone.

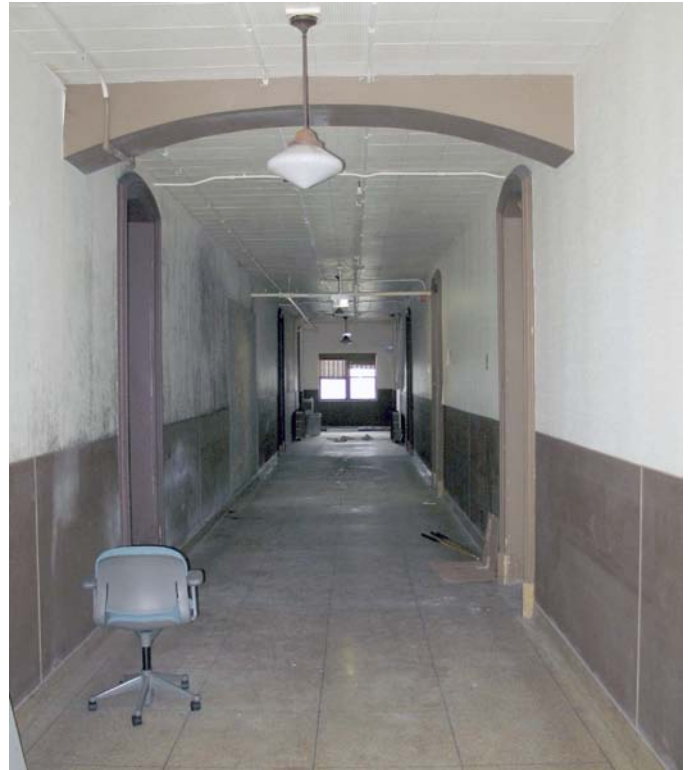
34 Mold, dirt, and pollutants on walls and floor. Vinyl wall covering and vinyl wall protection panels.

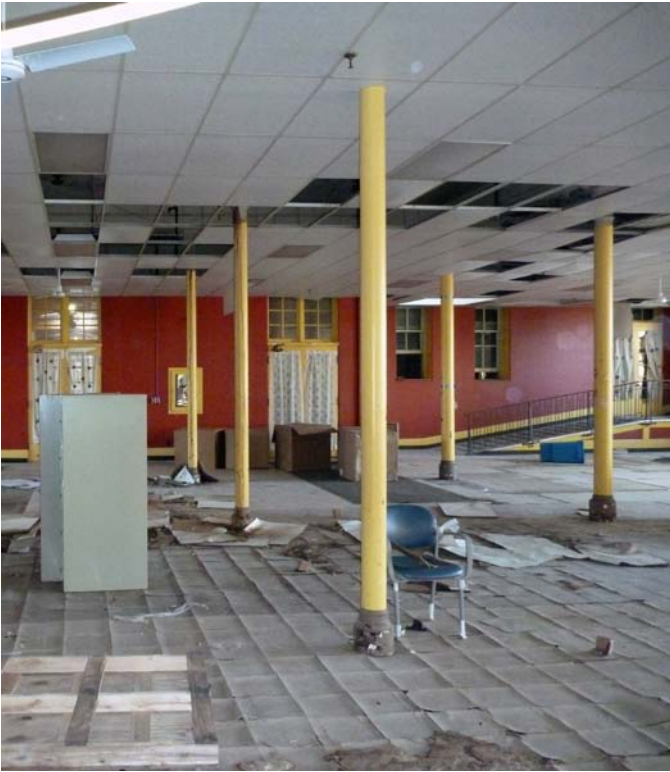
37 Non-compliant handicap ramp. Vinyl wall covering. Deteriorating floor tile.

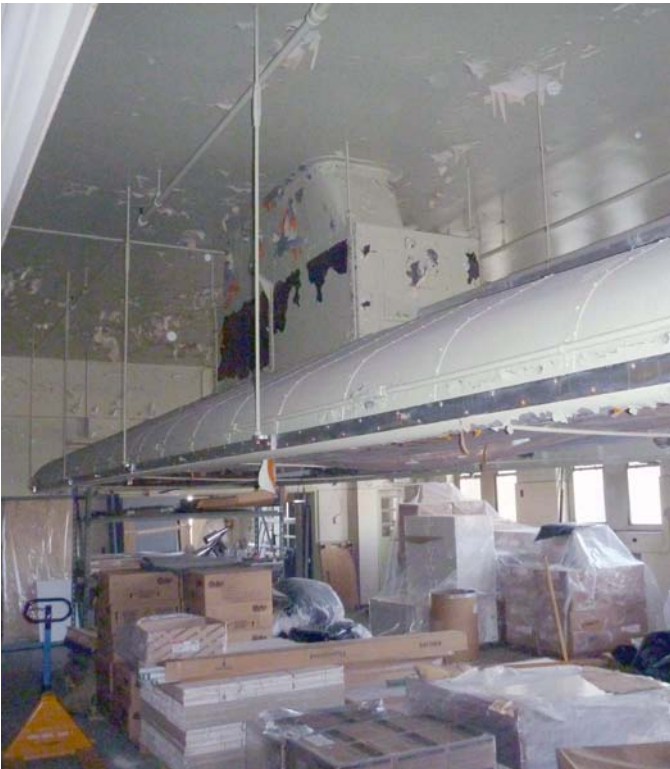
39 Peeling paint on walls, ceiling, ductwork and hood.

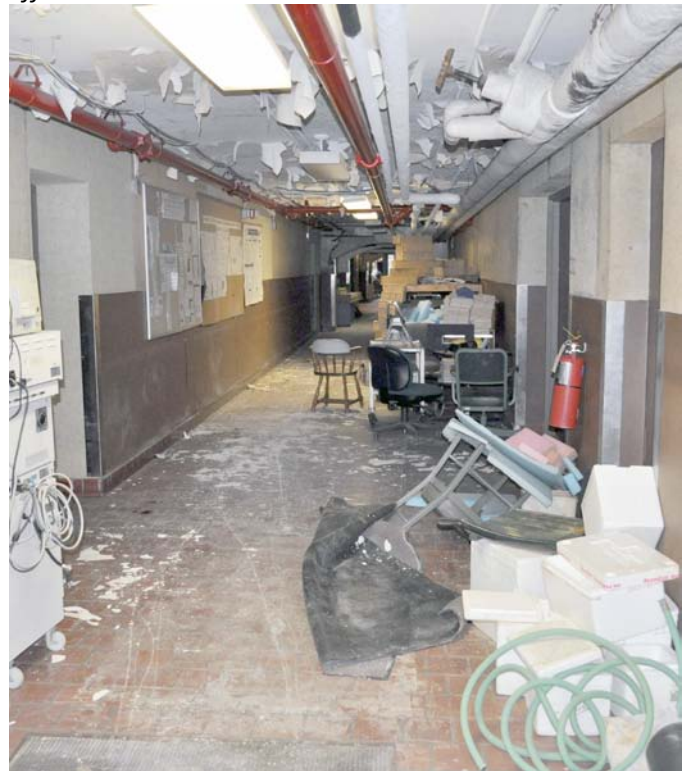
44 Peeling paint. Vinyl wall protection on walls. Dirt and pollutants.

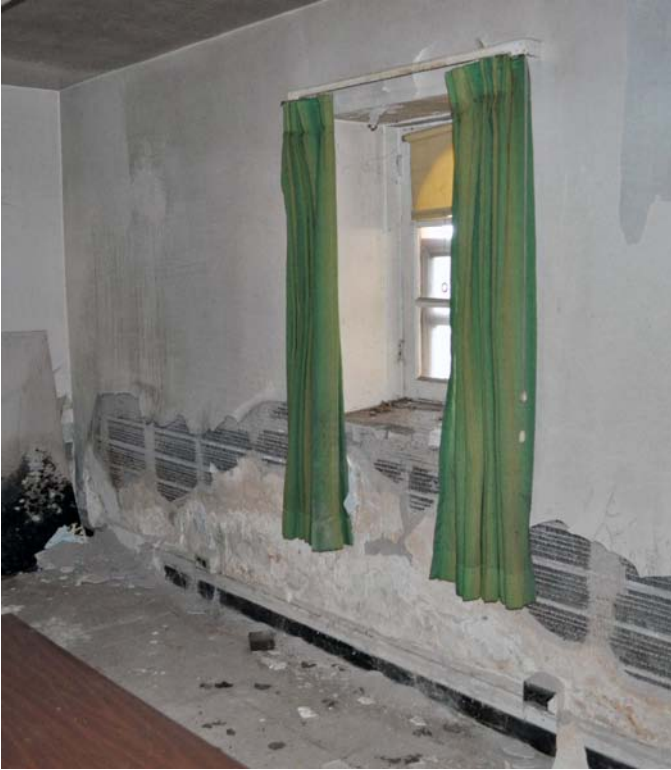
45 Water infiltration through foundation walls. Deteriorating plaster wall.

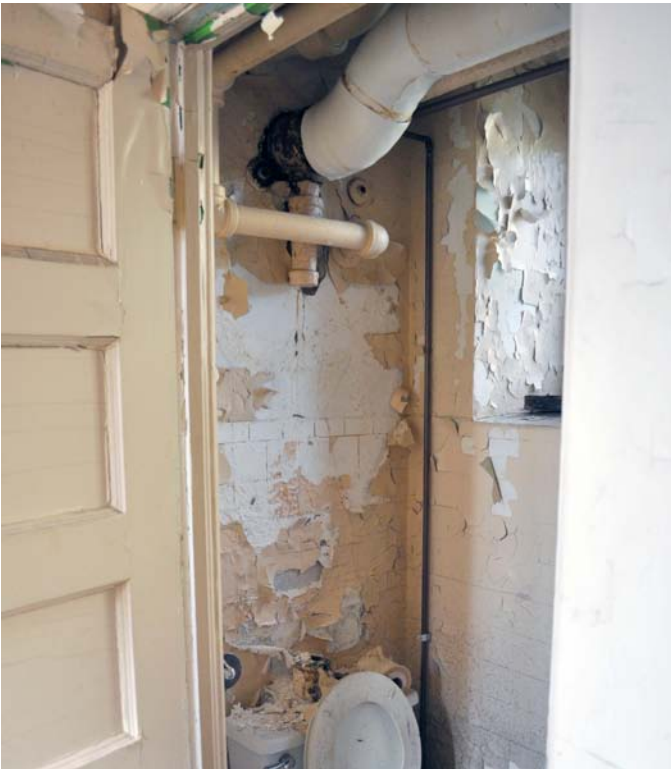
47 Painted ceramic tile. Peeling paint on door and walls. Deteriorating plaster wall. Non-handicap accessible toilet.

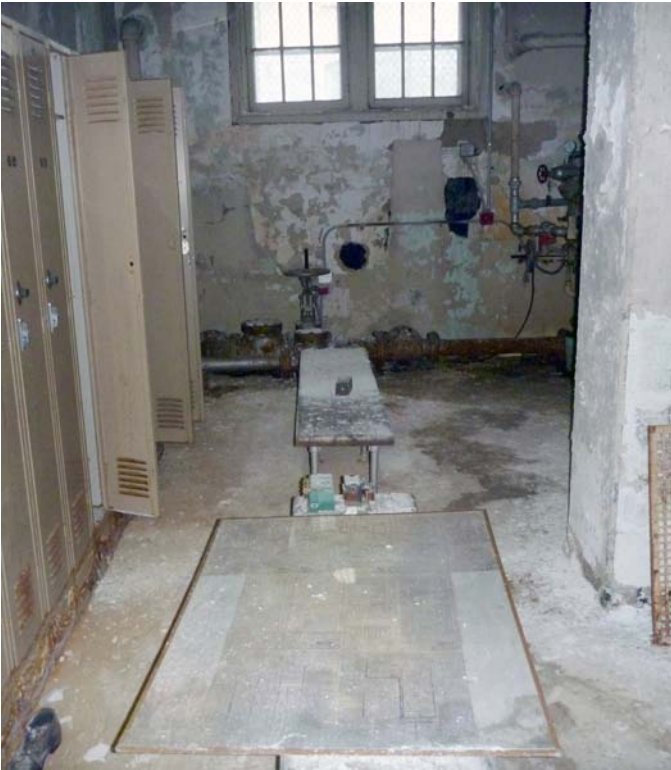
49 Water infiltration through foundation walls. Dirt and pollutants. Peeling paint.

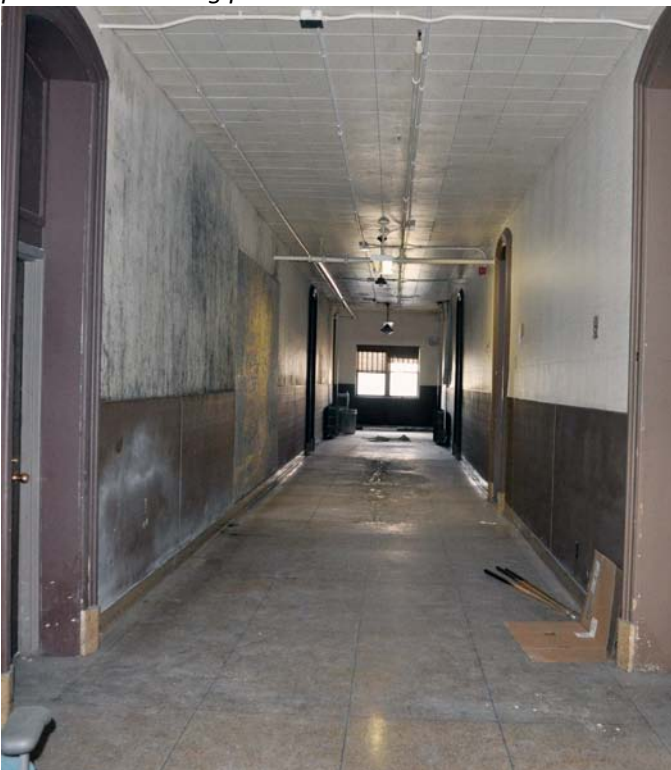
51 Dirt, mold and pollutants on walls and ceiling. Vinyl wall protection panel. Acoustical ceilings. Exposed pipes.

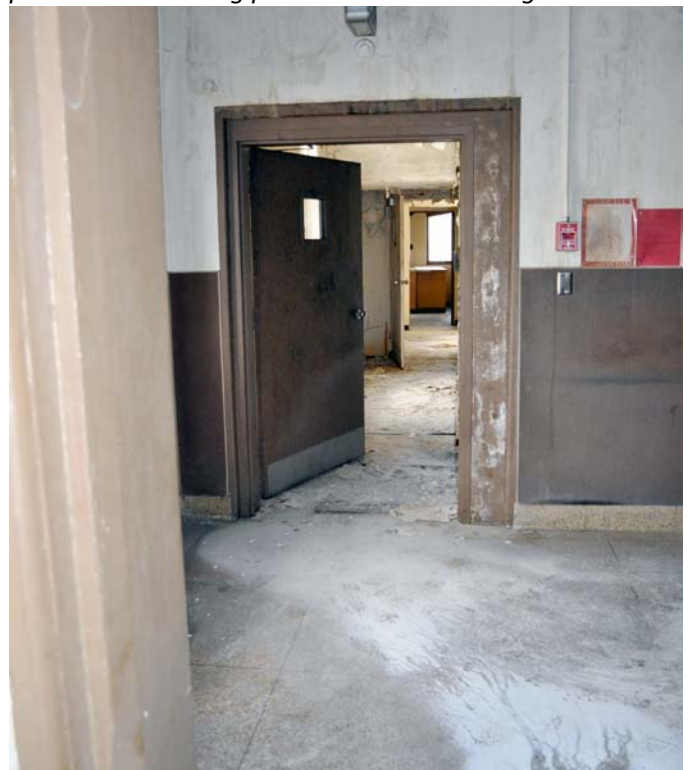
52 Dirt and pollutants. Peeling paint on door casing.

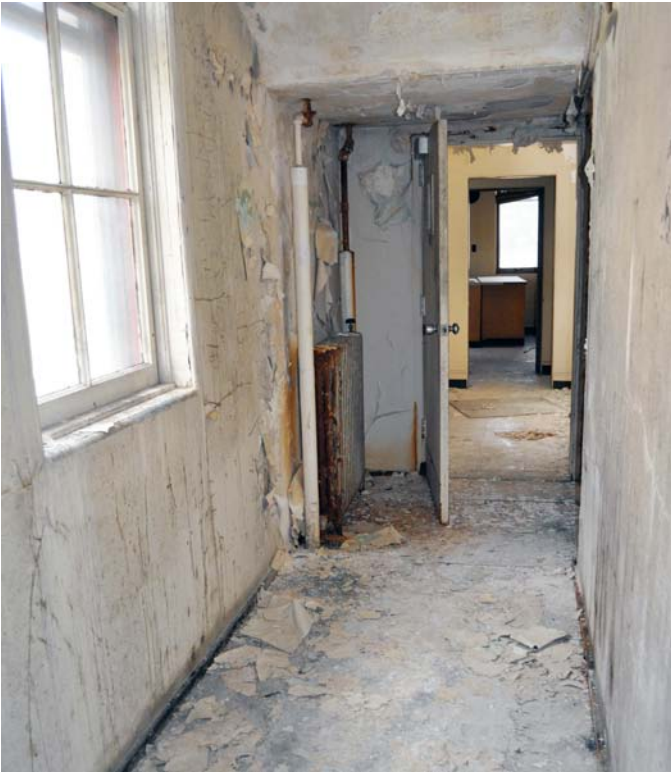
53 Peeling paint. Deteriorating plaster walls and ceilings.

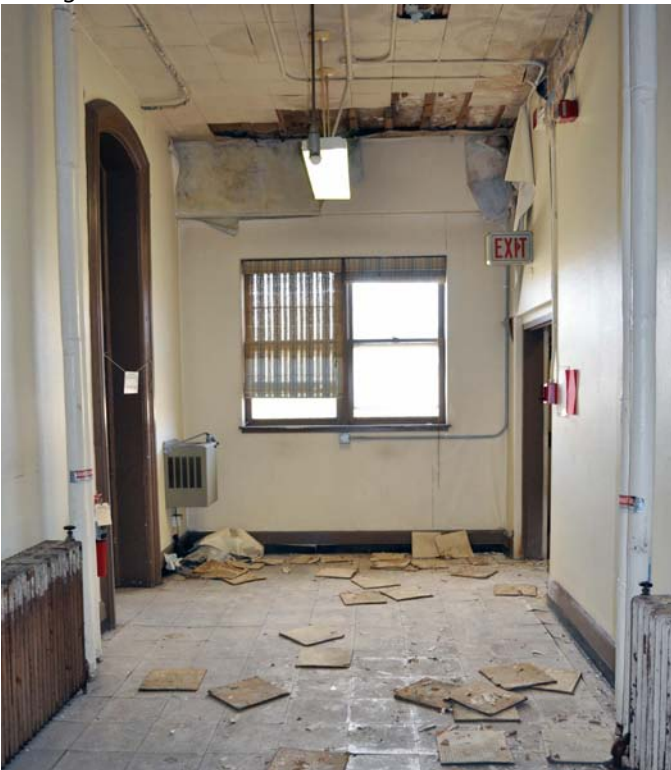
55 Water infiltration through ceiling. Dirt and pollutants. Peeling paint. Deteriorating acoustical ceiling and floor tiles.

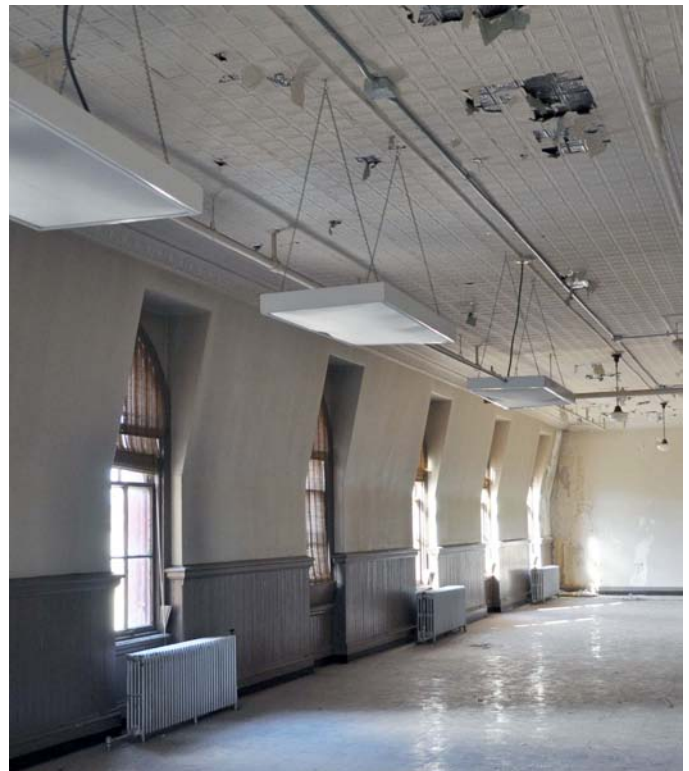
60 Peeling paint from tin ceiling, walls and wainscot.

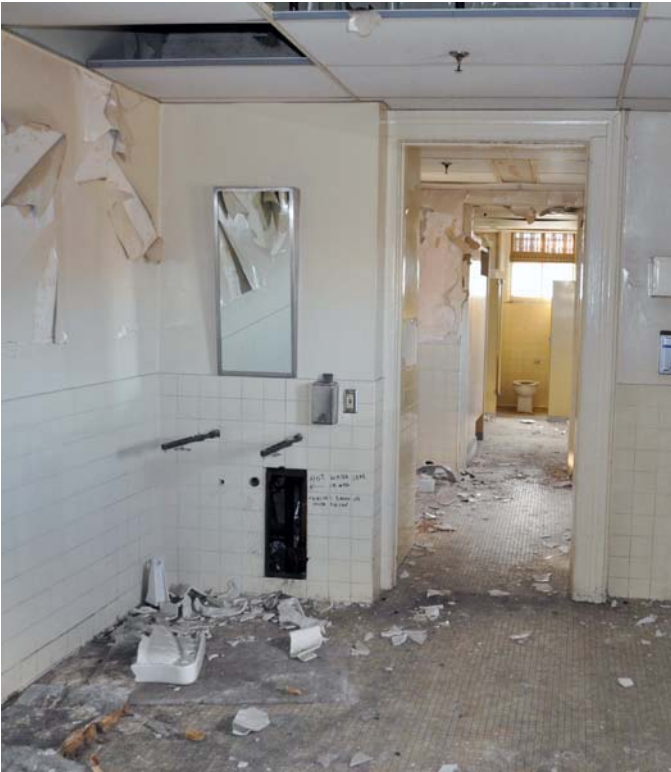
65 Dirt and pollutants on floors, walls, and ceilings. Demolished toilet room with missing fixtures.

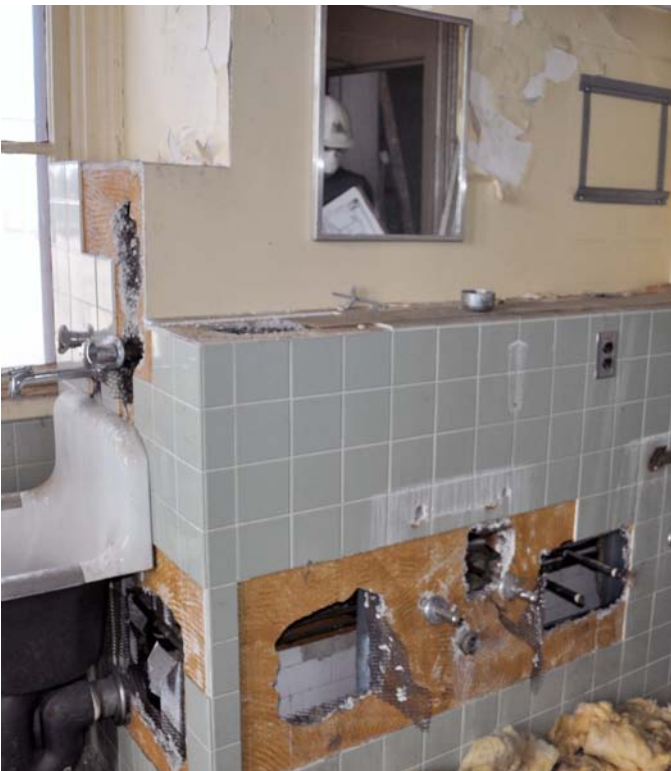
67 Dirt and pollutants. Peeling paint. Deteriorating plaster. Partially demolished toilet room.

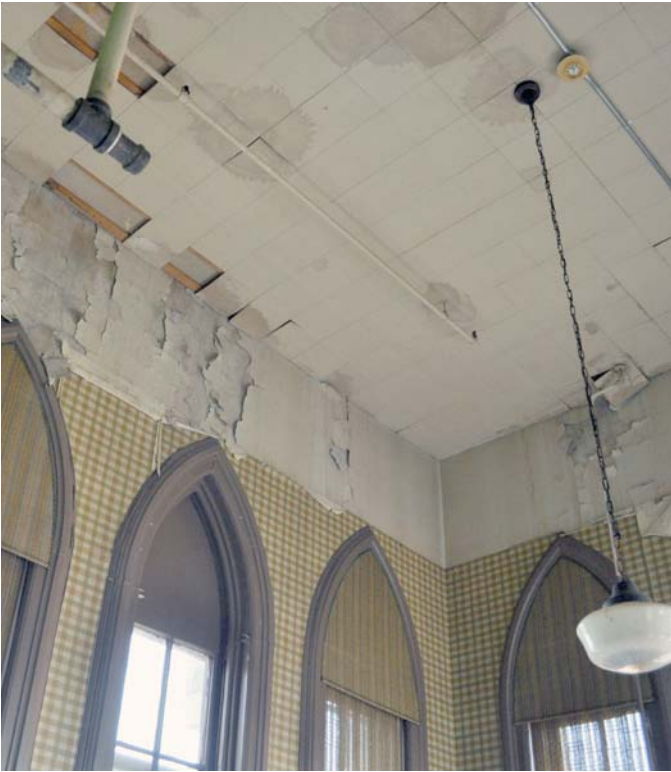
69 Water infiltration through ceiling. Dirt and pollutants. Peeling paint. Deteriorating plaster. Vinyl wall cover.

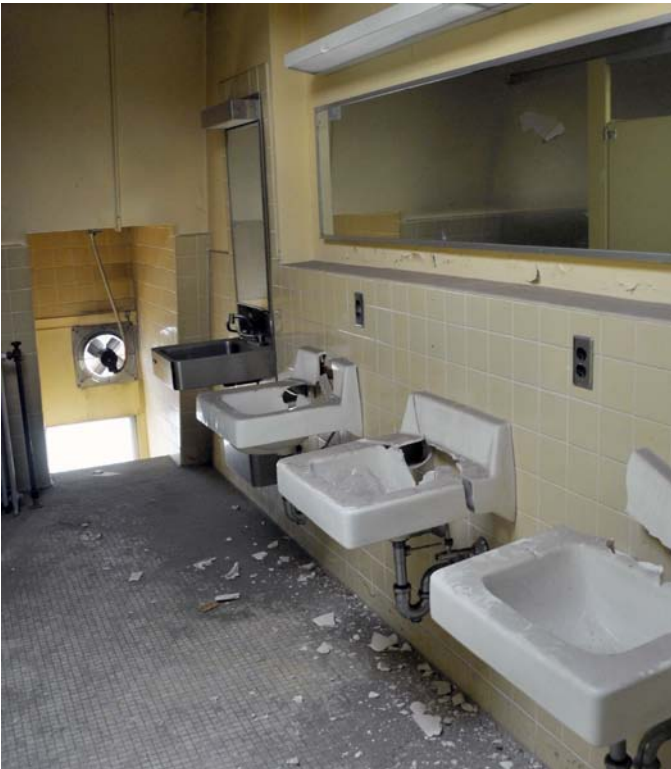
71 Dirt and pollutants. Peeling paint. Partially demolished non-handicap accessible toilet room.

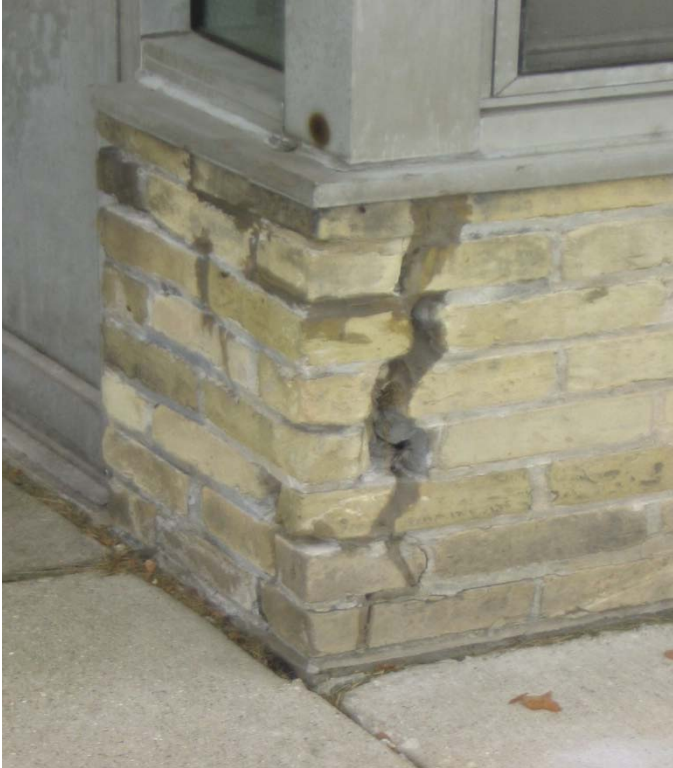
Overall, the existing foundation walls were found to be in 'fair' condition with significant cracking and surface deterioration present.

Significant cracking & surface deterioration is present on both the interior & exterior faces of the existing masonry stone bearing walls. In some instances, the masonry stone mortar has cracked and begun to break apart from the finished wall construction.

Photo 1: Deterioration & Cracking at Existing Masonry Foundation Walls.

Re-pointing of all existing masonry stone walls where cracking and deterioration has occurred should be addressed in the near future. Cleaning & removal of the surface deterioration that is currently present would also be recommended. All loose and missing stone should be removed and replaced with new to match existing.

In addition, it is recommended that further structural analysis be done to help determine the extent and type of additional repairs needed. Structural shoring of the existing foundation system may be required to prevent further structural damage to the existing foundation system.

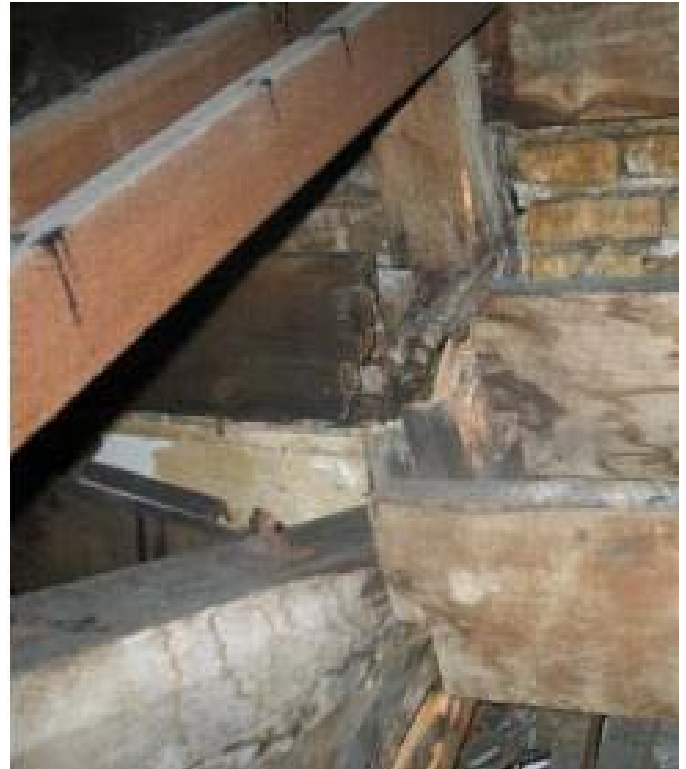
THE EXISTING ROOF CONSTRUCTION IS 'POOR' CONDITION. WHILE THE MAJORITY OF THE EXISTING ROOF FRAMING IS NOT VISIBLE, THERE IS EVIDENCE OF SIGNIFICANT MOISTURE DAMAGE AS EVIDENCE BY THE PRESENCE OF SURFACE DETERIORATION AND DISCOLORATION OF THE EXISTING INTERIOR CEILING FINISHES. MORE IMPORTANTLY, SIGNIFICANT PORTIONS OF THE EXISTING ROOF CONSTRUCTION HAVE ENCOUNTERED 'CATASTROPHIC' STRUCTURAL FAILURES. IN SOME LOCATIONS, ENTIRE PORTIONS OF THE EXISTING ROOF CONSTRUCTION HAVE COLLAPSED & FALLEN AWAY.

Photo 8: 'Catastrophic Roof Collapse of the 'Dining' Wing Roof.

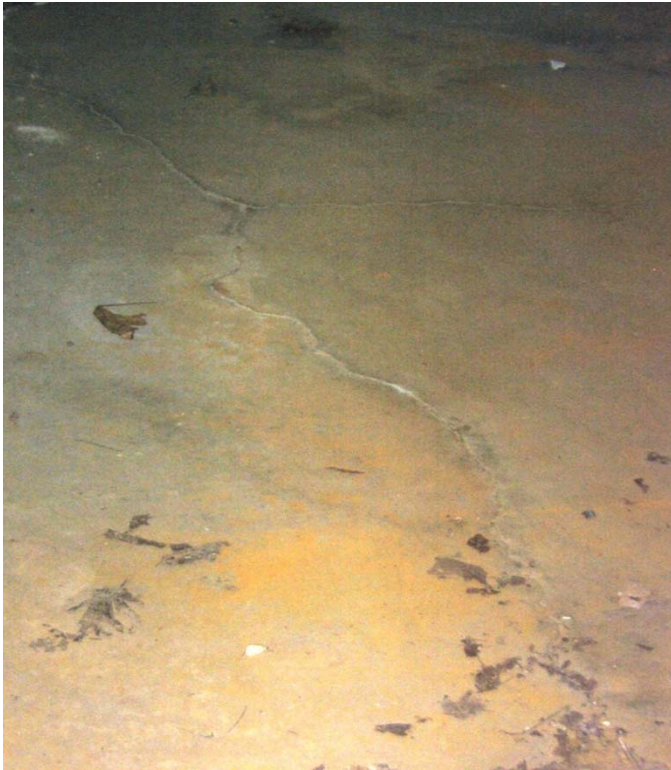
INTERIOR STRUCTURAL FOUNDATION SYSTEMS ARE GENERALLY IN 'FAIR' CONDITION. MINOR CRACKING TO THE EXISTING CONCRETE FLOOR SLABS HAS OCCURRED, WHILE MODERATE CRACKING & SURFACE DETERIORATION OF THE EXISTING MASONRY FOUNDATION WALLS HAS TAKEN PLACE.

Photo 9: Deterioration & Cracking at Existing Concrete Floor Slab.

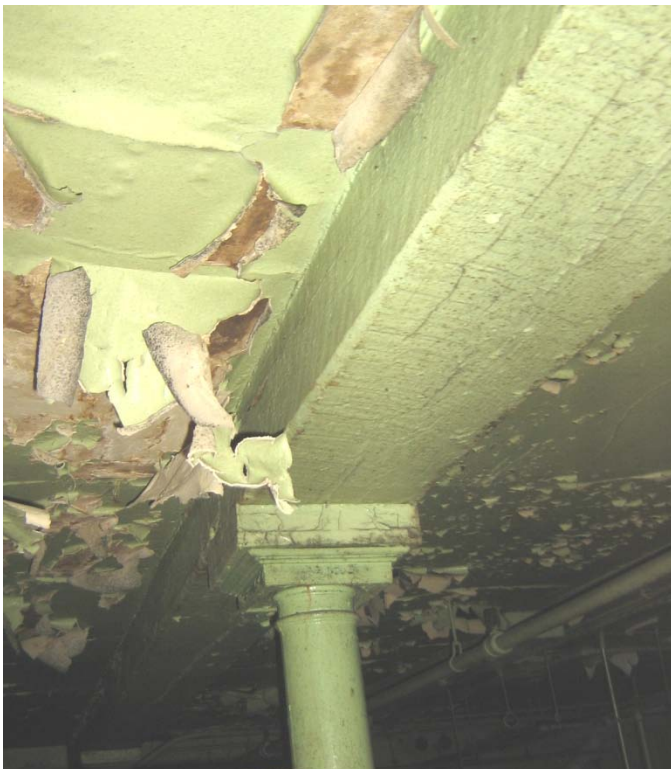
THE EXISTING FLOOR CONSTRUCTION IS 'POOR' CONDITION. WHILE THE MAJORITY OF THE EXISTING FLOOR FRAMING IS NOT VISIBLE, THERE IS EVIDENCE OF SIGNIFICANT MOISTURE DAMAGE AS EVIDENCE BY THE PRESENCE OF SURFACE DETERIORATION AND DISCOLORATION OF THE EXISTING INTERIOR CEILING FINISHES. IN ADDITION, MUCH OF THE WOOD FLOOR CONSTRUCTION APPEARED TO HAVE A NOTICEABLE 'SAG' TO IT.

Photo 11: Deterioration & Warping of Existing Wood Floor Beam & Associated Floor Framing.

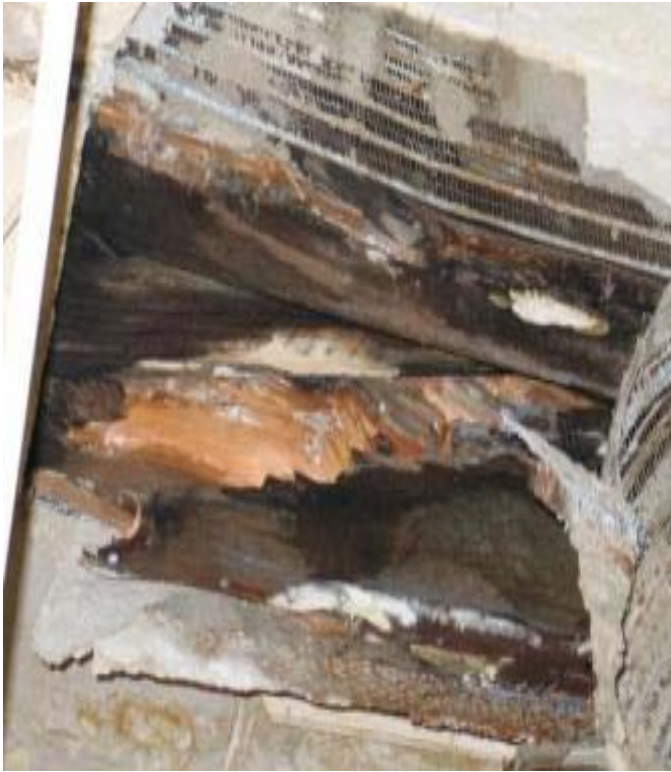
MORE IMPORTANTLY, SIGNIFICANT PORTIONS OF THE EXISTING FLOOR CONSTRUCTION HAVE ENCOUNTERED 'CATASTROPHIC' STRUCTURAL FAILURES. IN SOME LOCATIONS, ENTIRE PORTIONS OF THE EXISTING FLOOR CONSTRUCTION HAVE COLLAPSED & FALLEN AWAY.

Photo 13: 'Catastrophic Floor Collapse at First Floor 'Dining' Wing.

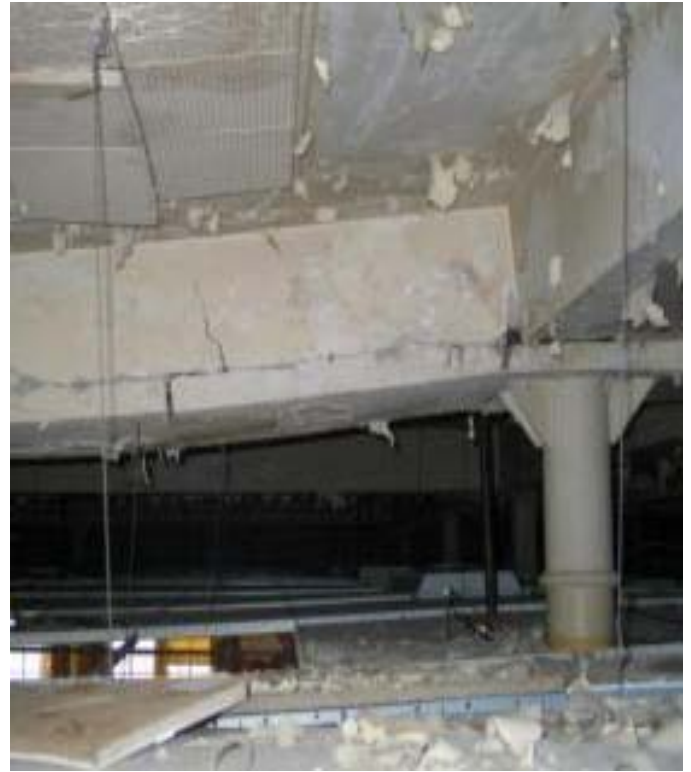
Photo 14: 'Catastrophic Floor Collapse at First Floor 'Dining' Wing.

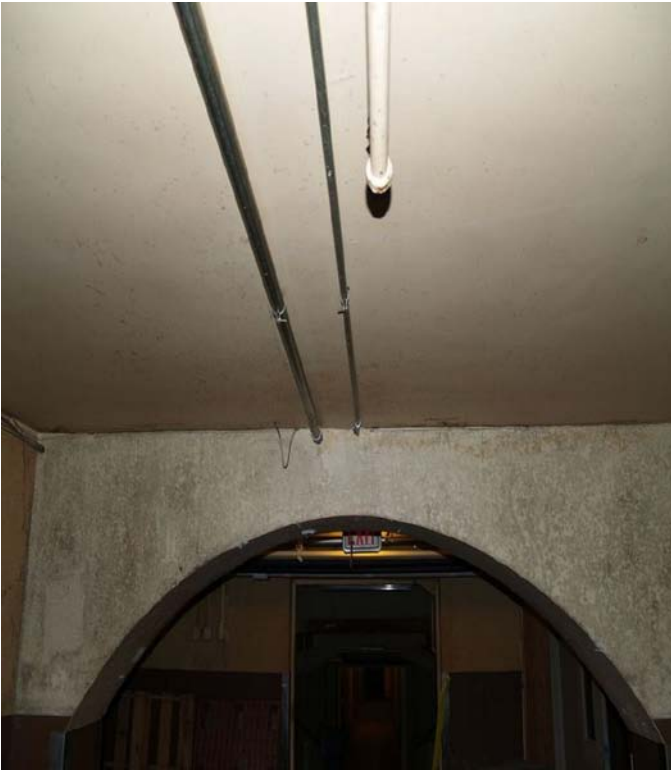
1 *Suspect mold growth on plaster wall in basement*

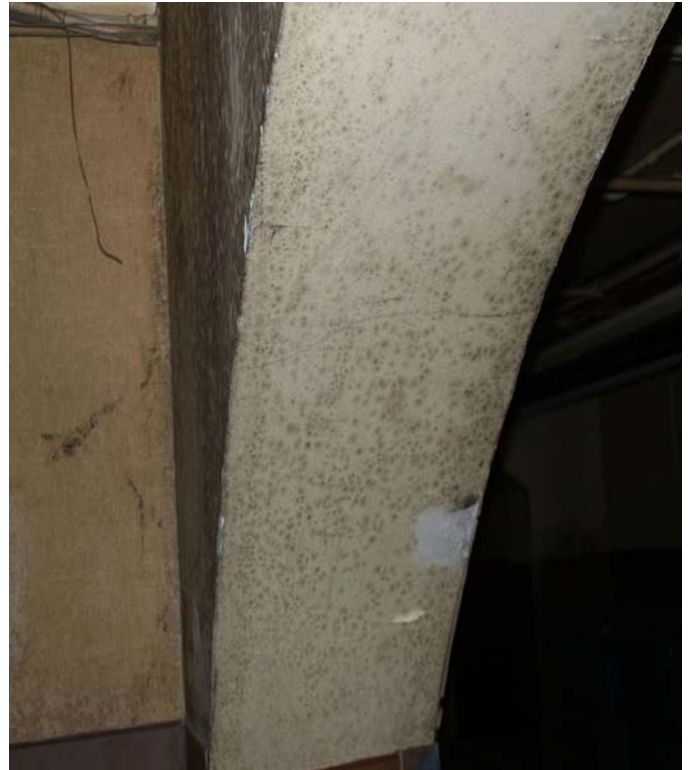
2 *Chipped paint and suspect mold growth on plaster wall in basement*

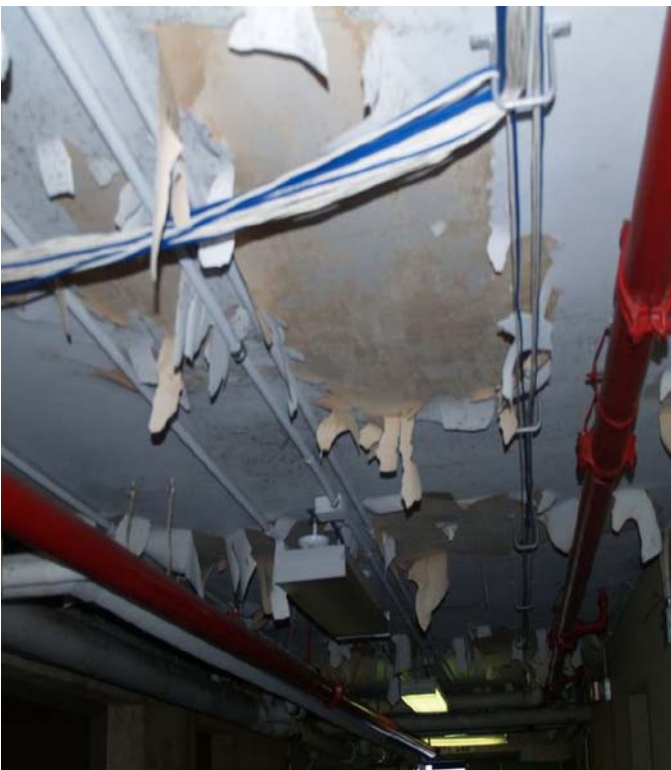
3 *Peeling paint on basement ceiling*

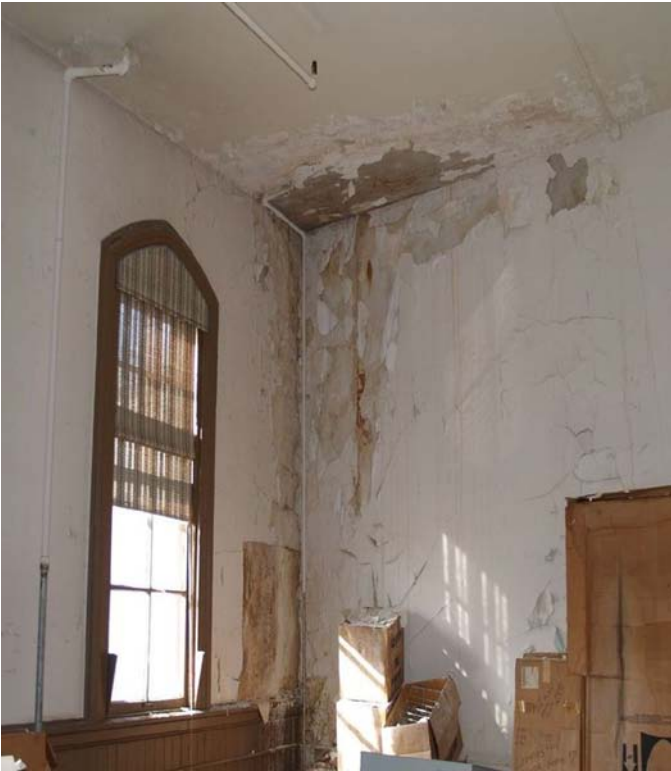
9 *Peeling paint and moisture water infiltration on second floor*

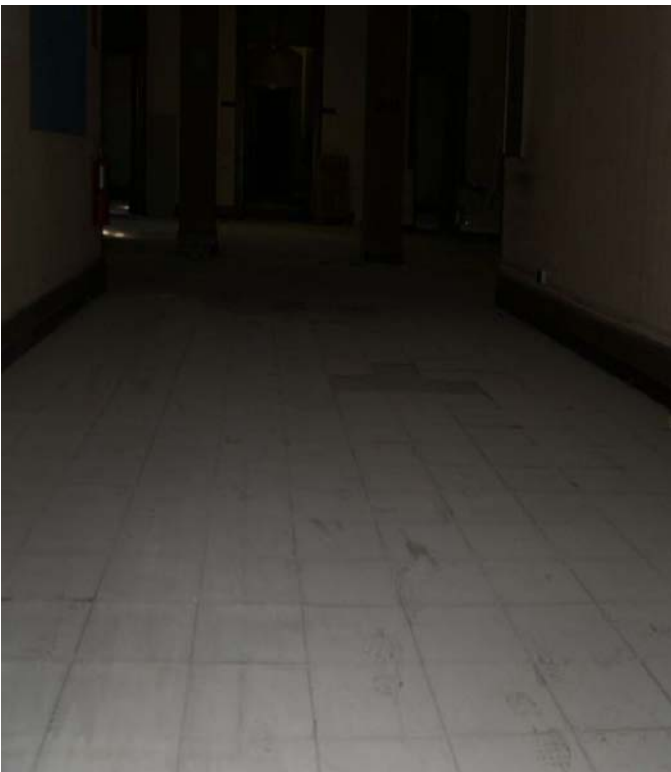
11 *Damaged and abraded vinyl floor tile on second floor*

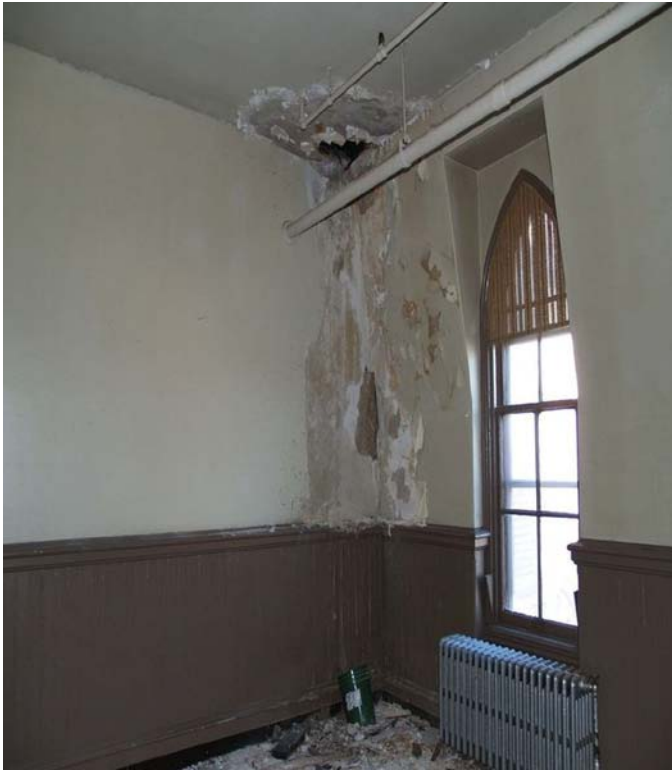
17 Peeling paint and water damaged plaster on third floor

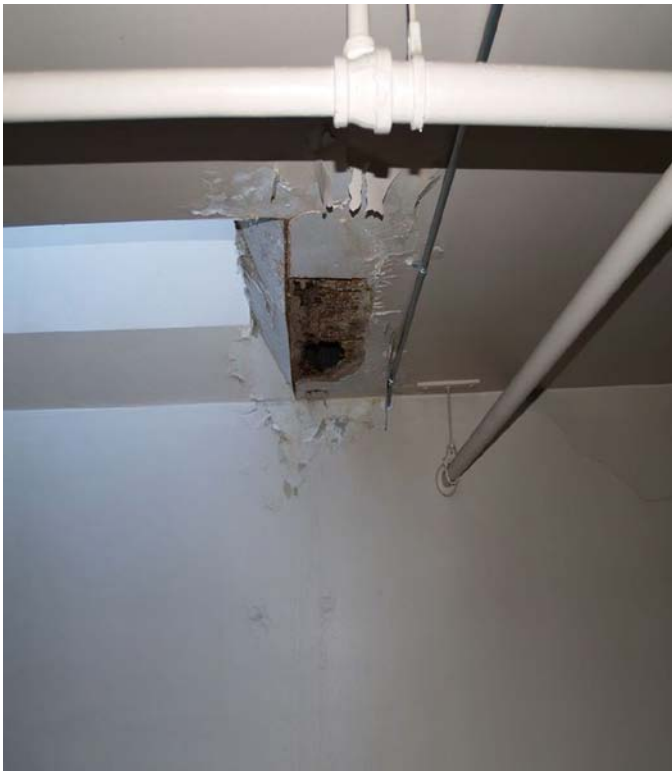
19 Water damage adjacent to skylight on fifth floor
